Appendix C2:
Alpine County Focus
Location Write Ups

Alpine County Focus Location Observations and Recommendations

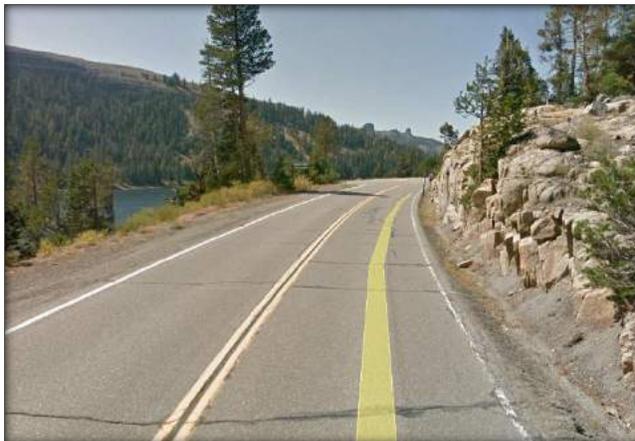
State Route 88 [SSAR Segment No. 8]

This section of State Route 88 begins at the Alpine/Amador County Line near the Kirkwood Inn and continues past Caples Lake. This segment includes the portion of roadway known as the 'Ice Box' which experiences frequent icy conditions during winter months. Caltrans is investigating potential Road Weather Information Systems (RWIS) and a potential ice detection and warning system to deploy at the Ice Box area.

The roadway consists of two 12' lanes and a shoulder ranging from 0' to 30' for pullouts. Several improvements have been made to this segment to aid drivers during winter driving conditions. The pavement, signage, and striping have all been recently updated. Caltrans is developing plans to improve roadway safety along SR 88 in Alpine County with a project to install centerline rumble strips, repair existing asphalt surfaces, restriping the roadway and improve warning signs and markings.

Based on SWITRS data from January 2013 to December 2017, there were 35 collisions on this segment. Most of the incidents were caused by travelling at an unsafe speed and resulted in hitting an object.

- Conduct a Roadside Signage Safety Audit (RSSA) and update roadside signage with a focus on curve warnings, edge delineation and nighttime visibility
- Planned Caltrans project scheduled for 2018 will install rumble strips, repair damaged pavement and upgrade signs and markings

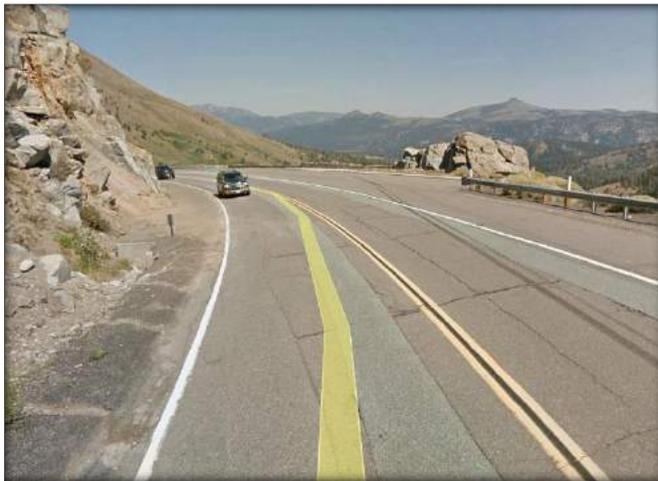
State Route 88 [SSAR Segment No. 9]

This portion of State Route 88 shares the same features as the adjacent segment, described above. The roadway is winding and narrows in several areas, leaving vehicles driving next to steep embankments. These embankments, or the guardrails protecting them, result in the hit object type collisions caused by unsafe speed. Caltrans is developing plans to improve roadway safety along SR 88 in Alpine County with a project to install centerline rumble strips, repair of existing asphalt surfaces, restriping the roadway and improving warning signs and markings.

Based on SWITRS data from January 2013 to December 2017, 40 collisions occurred on this segment. Most of the collisions were caused by unsafe speed and resulted in hitting an object.

- Conduct a Roadside Signage Safety Audit (RSSA) and update roadside signage with a focus on curve warnings, edge delineation and nighttime visibility
- Planned Caltrans project scheduled for 2018 will install rumble strips, repair damaged pavement and upgrade signs and markings

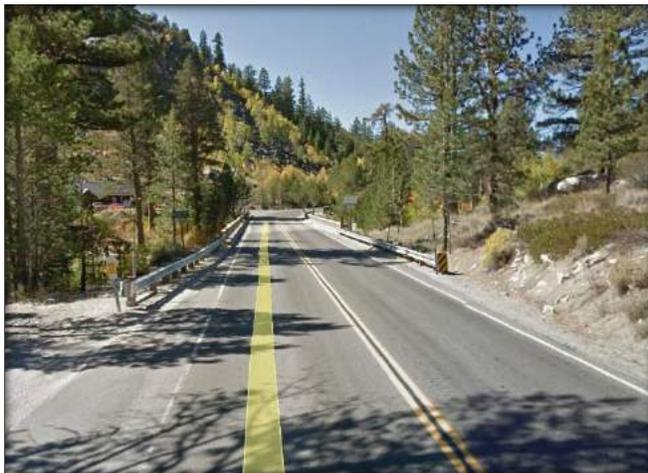
State Route 88/89 [SSAR Segment No. 11]

This portion of State Route 88/89 connects the community of Sorensens to Woodfords and Alpine Village. Most of this segment has 12' lanes with 2' paved shoulders. The pavement, signage, and striping have all been recently upgraded. Large trees parallel the roadway on both sides. Caltrans is developing plans to improve roadway safety along SR 88/89 in Alpine County with a project to install centerline rumble strips, repair of existing asphalt surfaces, restriping the roadway and improving warning signs and markings.

This segment becomes difficult to traverse during winter driving conditions. Vehicles travelling at an unsafe speed during inclement weather do not have a lot of room for error when making turns, which results in a high number of hit object type collisions. Public comments have been provided regarding vehicles stopped in the shoulder and encroaching on the roadway when installing tire chains.

Based on SWITRS data from January 2013 to December 2017, there were 44 collisions on this segment. An average traffic volume of 3,000 vehicles per day resulted in a crash rate of 1.32 Coll/MVM. Most of the crashes were due to unsafe speed and resulted in hitting an object.

- Conduct a Roadside Signage Safety Audit (RSSA) and update roadside signage with a focus on curve warnings, edge delineation and nighttime visibility
- Planned Caltrans project scheduled for 2018 will install rumble strips, repair damaged pavement and upgrade signs and markings
- Consider adding new vehicle chain installation turn outs

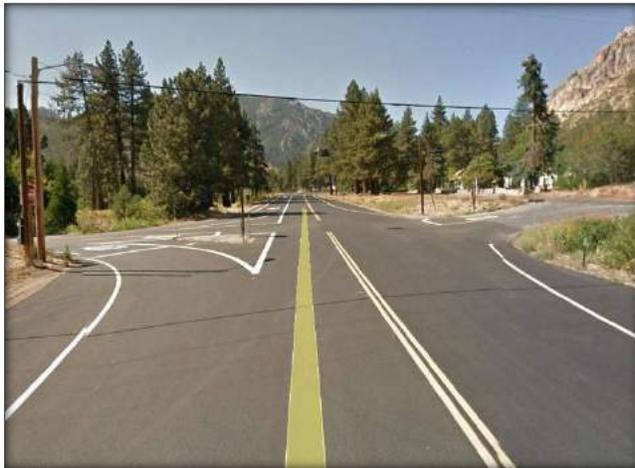
SR 88 and SR 89 (Towards Markleeville)

To differentiate between two intersections with the same name, this intersection is with State Route 89 heading south towards Markleeville. SR 89 is stop controlled while SR 88 has the right of way. Flashing beacons overhead help warn motorists of the intersection. SR 88 has a designated right turn lane but not a left turn lane onto SR 89. SR 89 has one lane for left turns and one lane for right turns and through movements.

Due to the large trees, and a horizontal curve on SR 88, which limits sight distance for motorists on SR 89 to determine when it is safe for them to proceed through the stop sign.

Based on SWITRS data from January 2013 to December 2017, there were 6 collisions at this intersection. Half of these collisions were caused by unsafe speed while 33% resulted in a rear end collision.

- Conduct a Roadside Signage Safety Audit (RSSA) and update roadside signage with a focus on intersection warning signs, edge delineation and nighttime visibility
- Planned Caltrans project scheduled for 2018 will install rumble strips, repair damaged pavement and upgrade signs and markings
